# Manhole Inspection Summary

Manhole # S25M\_\_025MH

Insp Date: **3/6/08 2:10 PM**

**Location** Address: **1236 Sargeant St**

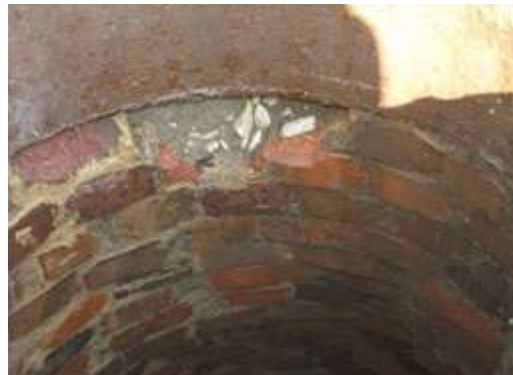
Defect 3

missing brick 6 oclk area ( infiltration)

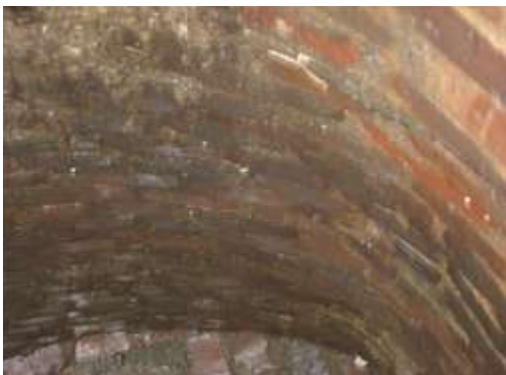
Defect 2

Infiltration: ☐ None ☐ Joint ☐ Cracks ☐ Mortar ☐ Roots ☒ **Wall**

infiltration in barrel area

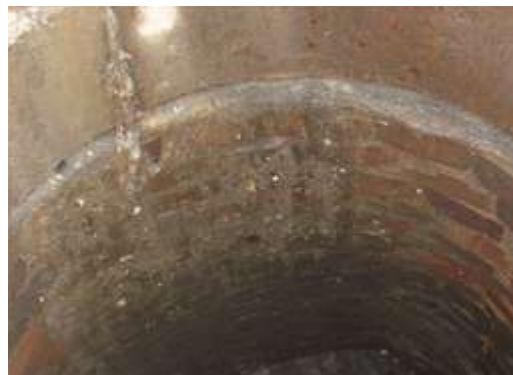
Defect 1

Condition: ☐ Sound ☐ Cracked ☐ Root Intrusion ☒ **Loose Brick** ☒ **Deteriorated**

Infiltration: ☐ None ☒ **Joint** ☐ Cracks ☒ **Mortar** ☐ Roots ☒ **Wall**

infiltration joint chimney-frame/corbel, gap between chimney and frame

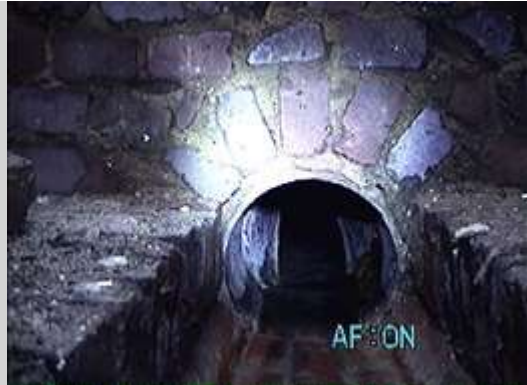
12 O'Clock Outflow

Pipe Height: **8.4** (in.) Rod and Bar (Angled)  
Pipe Material: **Clay** ☐ Pipe Lined  
Invert Depth: **7.54** (ft.) Flow Characteristics: **Slow**  
Deposits: ☒ None ☐ Mud ☐ Sludge ☐ Debris ☐ Grease  
Silt Depth: **0** (in.) Deposits Extent:  
Infiltration: **None** Pipe Seal Cond: **Sound**

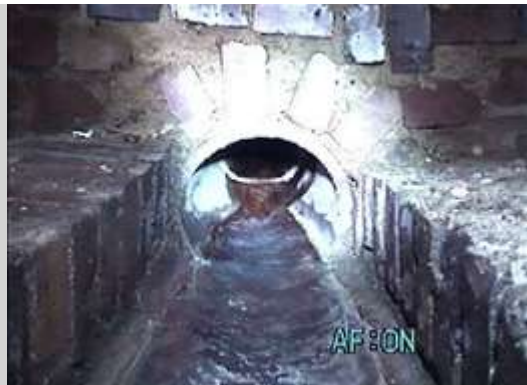
6 O'Clock Inflow

Pipe Height: **8.4** (in.) Rod and Bar (Angled)  
Pipe Material: **Clay** ☐ Pipe Lined  
Invert Depth: **7.63** (ft.) Flow Characteristics: **Slow**  
Deposits: ☒ None ☐ Mud ☐ Sludge ☐ Debris ☐ Grease  
Silt Depth: **0** (in.) Deposits Extent:  
Infiltration: **None** Pipe Seal Cond: **Sound**
